OWNERS MANUAL

AIR OPERATED CHASSIS PUMP

PORTABLE LUBRIGUN 120 LB DRUM SIZE 50:1 RATIO PUMP

MODEL ATD5217

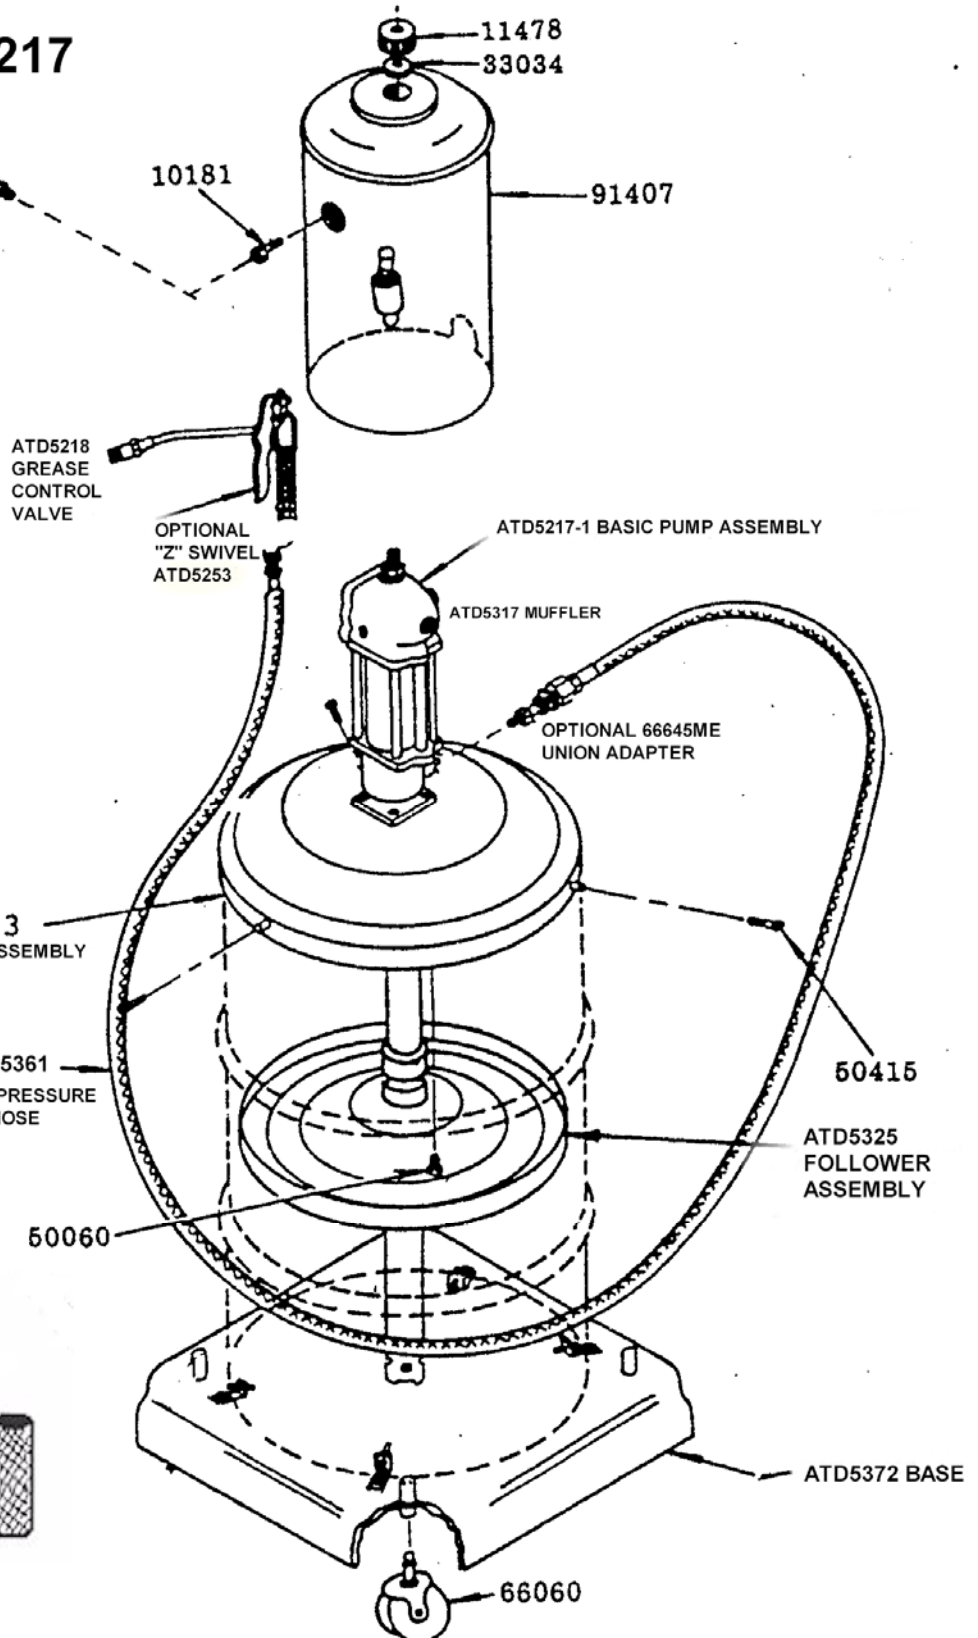
815 Coupler
11660 Fitting

Grease Strainer
ATD-5356 for
Downtube

Instruction for Assembly of ATD-5217 Lubrigun		
Assemble Drum Cover to Pump	Insert end of pump tube (ATD-5217-1) through hole in the drum cover (45733). Line up holes in drum cover (45733) with the pump outlet body (ATD-5217-1). Place the screws (50060) in their respective holes in the drum cover (45733) and tighten drum cover (45733) to the bottom of the pump body (ATD-5217-1)	
NOTE: Many of the smaller parts might have already been installed for you, such as the muffler (2601) pump cover (91407) and extension (10181).		
Assemble the four casters (66060ME) to the roll around base (ATD-5372)

Install the extension tube (10181) into the air inlet port of the air motor. You might need Teflon tape to ensure a leak-free connection. Place air motor (91407) on pump head (ATD-5217-1). Place washer (33034) and cover nut (11478) on pump stud and thread air motor cover securely in place. Ensure that you align holes for 11660 air nipple and extension 10181.		
The Air coupler (815ME) and nipple (11660) are packed in a separate bag.		
Thread Air Nipple (11660) into extension (10181) connected through pump cover opening; Thread into pump head opening. Use Teflon tape to seal threads to prevent air leakage if necessary.		
Assemble air coupler (815) to an air hose of sufficient length so that the lubrigun can be moved to cover the entire lubrication area with the hose attached. When air coupler (815) is attached to air coupler nipple (11660), lubrigun is ready for operation. To release air coupler (815), draw back on the coupler sleeve (815) and slide away from the nipple (11660).

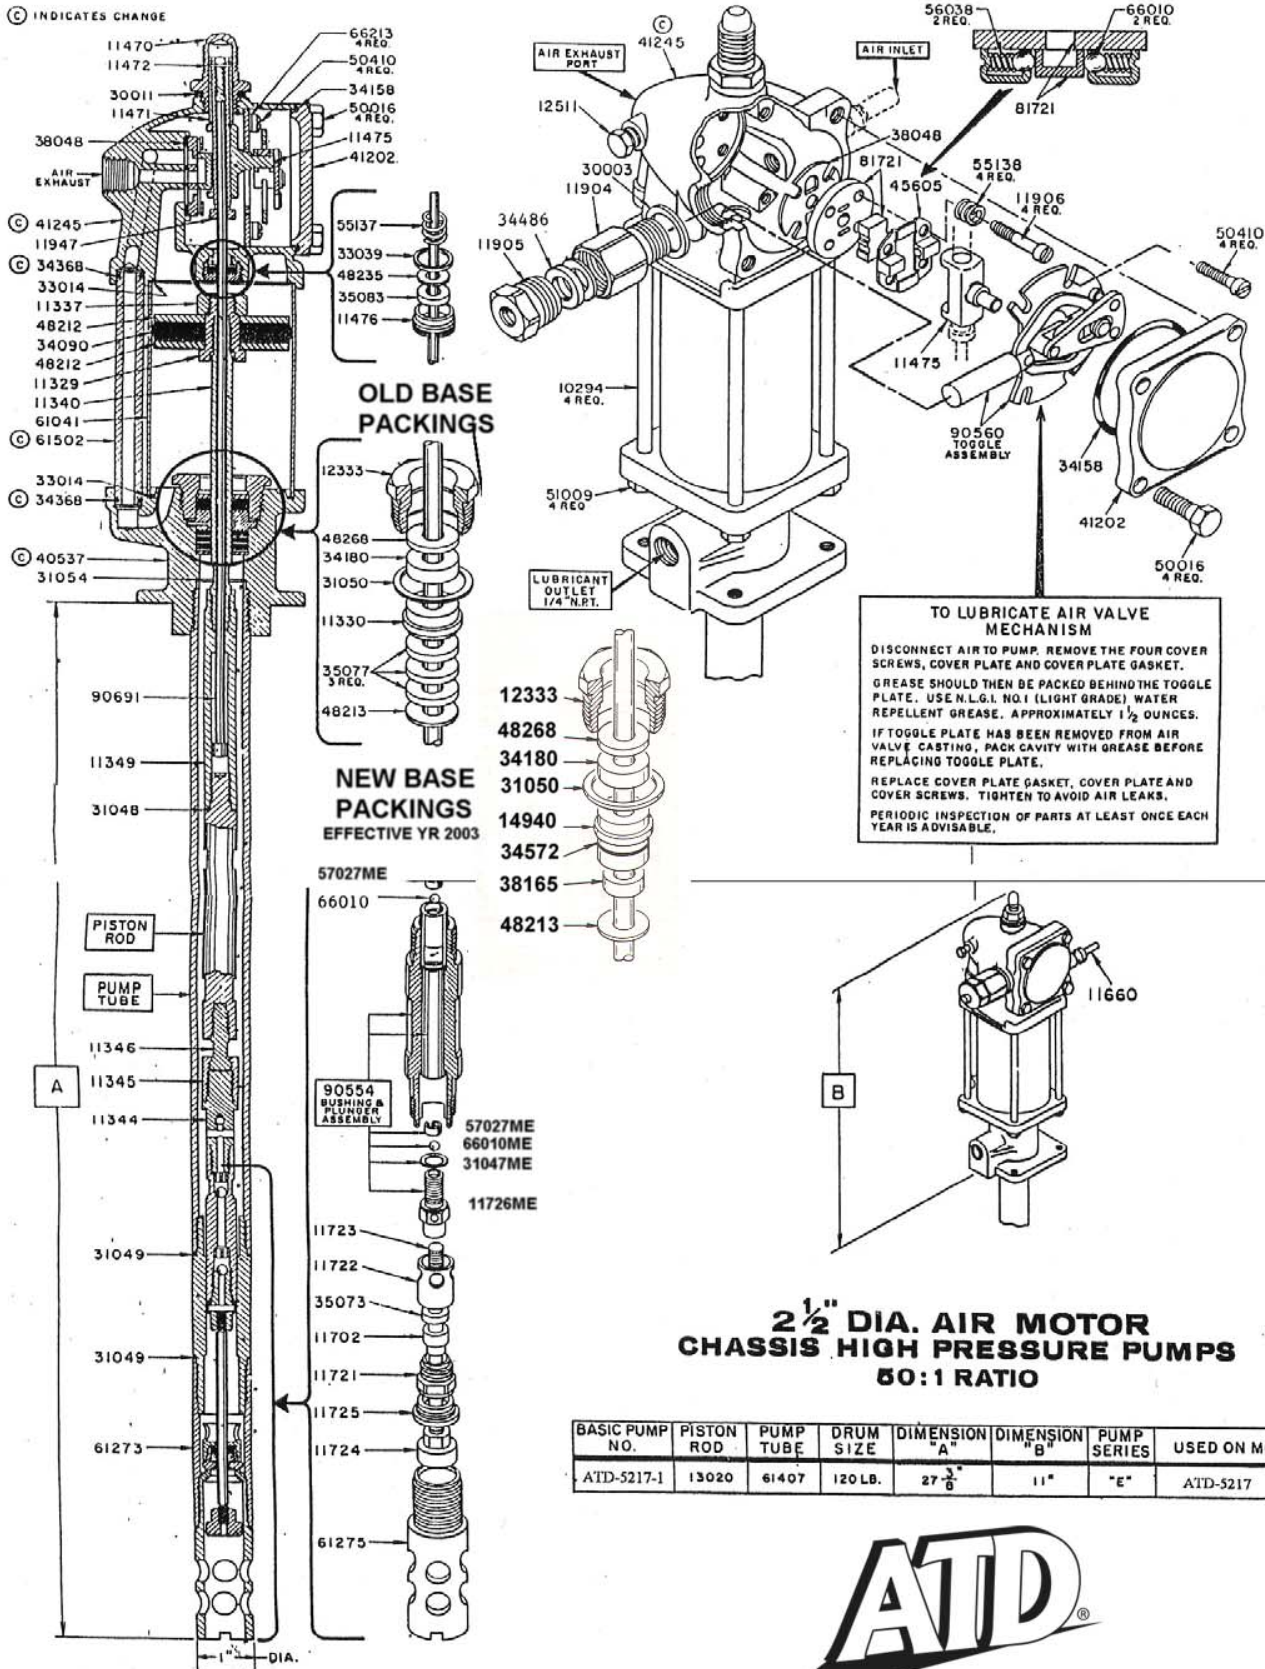
PUMP ASSEMBLY

**2 1/2" DIA. AIR MOTOR
CHASSIS HIGH PRESSURE PUMPS
50:1 RATIO**

BASIC PUMP NO.	PISTON ROD	PUMP TUBE	DRUM SIZE	DIMENSION "A"	DIMENSION "B"	PUMP SERIES	USED ON MODELS
ATD-5217-1	13020	61407	120 LB.	27 3/8"	11"	"E"	ATD-5217

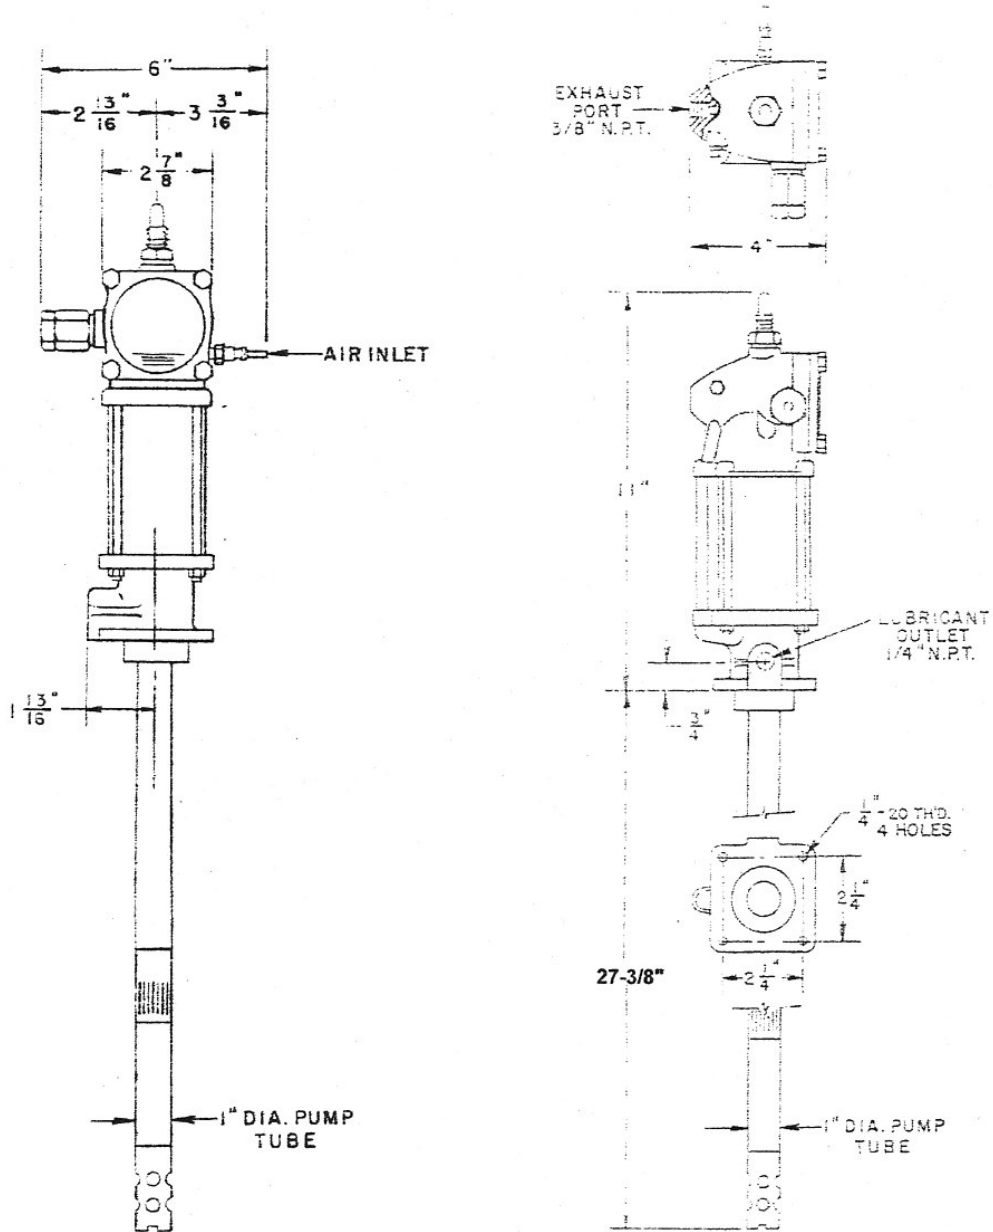
ATD-5217-1

2-1/2" AIR MOTOR OPERATED PUMPS
MODEL ATD5217 Pump Assembly (ATD5217-1-Pump)
(CHASSIS --- 50:1 RATIO)

PART #	DESCRIPTION	PART #	DESCRIPTION	PART #	DESCRIPTION
10294	Tie Rod	12209	Coupling Stud*	41202	Cover Casting
11329	Air Piston Bolt	12211	Coupling Nut*	41245	Air Valve Casting
11330	Gland Spacer in Base(Old Version)	12333	Gland Packing Nut	45605	Valve Guide Plate
11337	Air Piston Nut	12511	Pipe Plug	48213	Gland Packing Washer
11340	Air Motor Piston Rod	14940ME	Gland Spacer in Base(New Version)	48235	Packing Washer
11344	Plunger Adapter	13020	Piston Rod	34486	O-Ring
11345	Coupling Nut	13363	Valve Cap	48237	Plunger Packing Washer*
11346	Coupling Stud	30003	Packing Nut Gasket	48268	Gland Packing Washer*
11349	Piston Rod Connector	30011	Valve Cap Gasket	T-2489	Valve Cover Screw*
11470	Valve Cap	31047	Check Seat Gasket*	50016	Valve Cover Screw
11471	Trip Rod Collar	31048	Connector Gasket	50410	Toggle Plate Screw
11472	Trip Rod Pin	31049	Bushing Gasket	51009	Tie Rod Nut
11475	Trip Shoe	31050	Gland Gasket	55137	Trip Rod Packing Spring

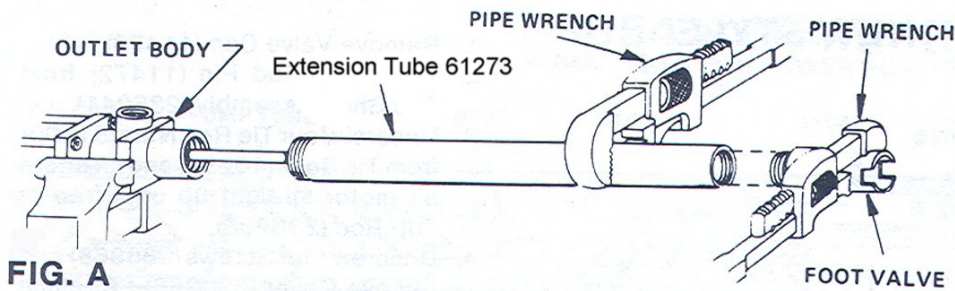
FIG. A

FIG A. (See Fig. A) Lay pump horizontal in vise and grip outlet body tightly in vise jaws. Hold Extension Tube (61273) and unscrew Priming Tube (61275).

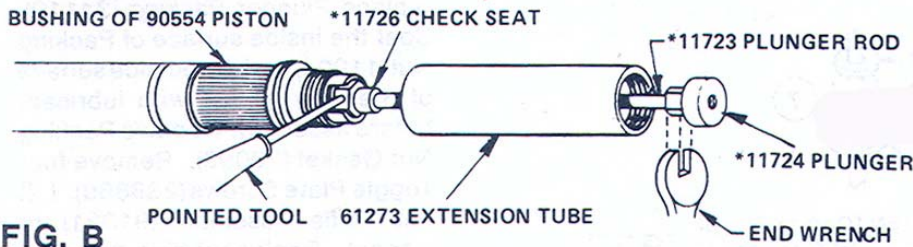
FIG. B

Fig B. (See Fig. B) Pull Plunger (11724) straight out until Plunger Rod (11723) is extended as far as possible out of the Extension Tube (61273). Hold bushing of Piston (90554) and unscrew Extension Tube (61273).

Center Extension Tube (61273) between end of piston bushing and Plunger (11724). Insert any pointed tool in through hole at Base of Check Seat 11726.

Note: Plunger may unscrew from Plunger Rod (11723) or plunger rod may unscrew from Check Seat (11726). Extension Tube (61273) can be removed from free end of Plunger Rod (11723).

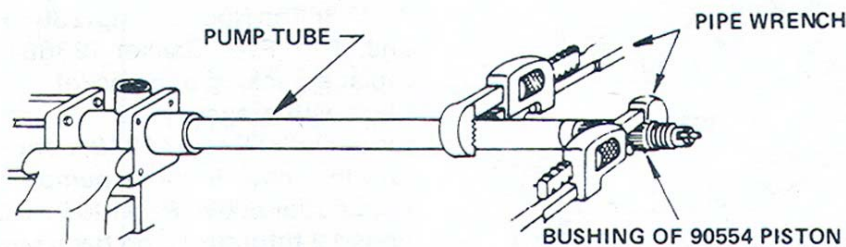
FIG. D

Fig D. (See Fig. D) Removing Bushing and Plunger Assembly (90554ME); Hold pump tube and unscrew bushing of Piston (90554). Bushing should slide off once unthreaded from the Pump Tube.

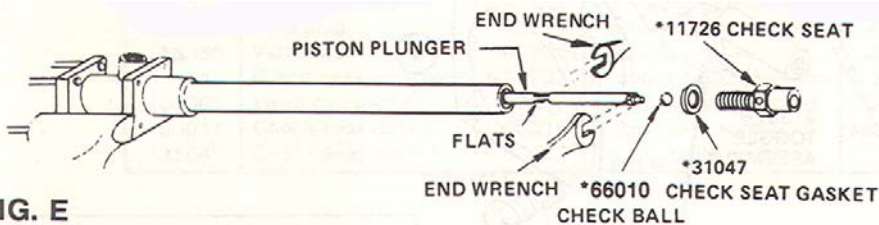
FIG. E

Fig E. Grip two flats at top of piston plunger with an end wrench and remove Check Seat (11726).

Note #1: Check Ball (66010) may remain in plunger after Check Seat (11726) is removed. To remove check ball tilt pump in vise and gently tap top of plunger at location of two flats.

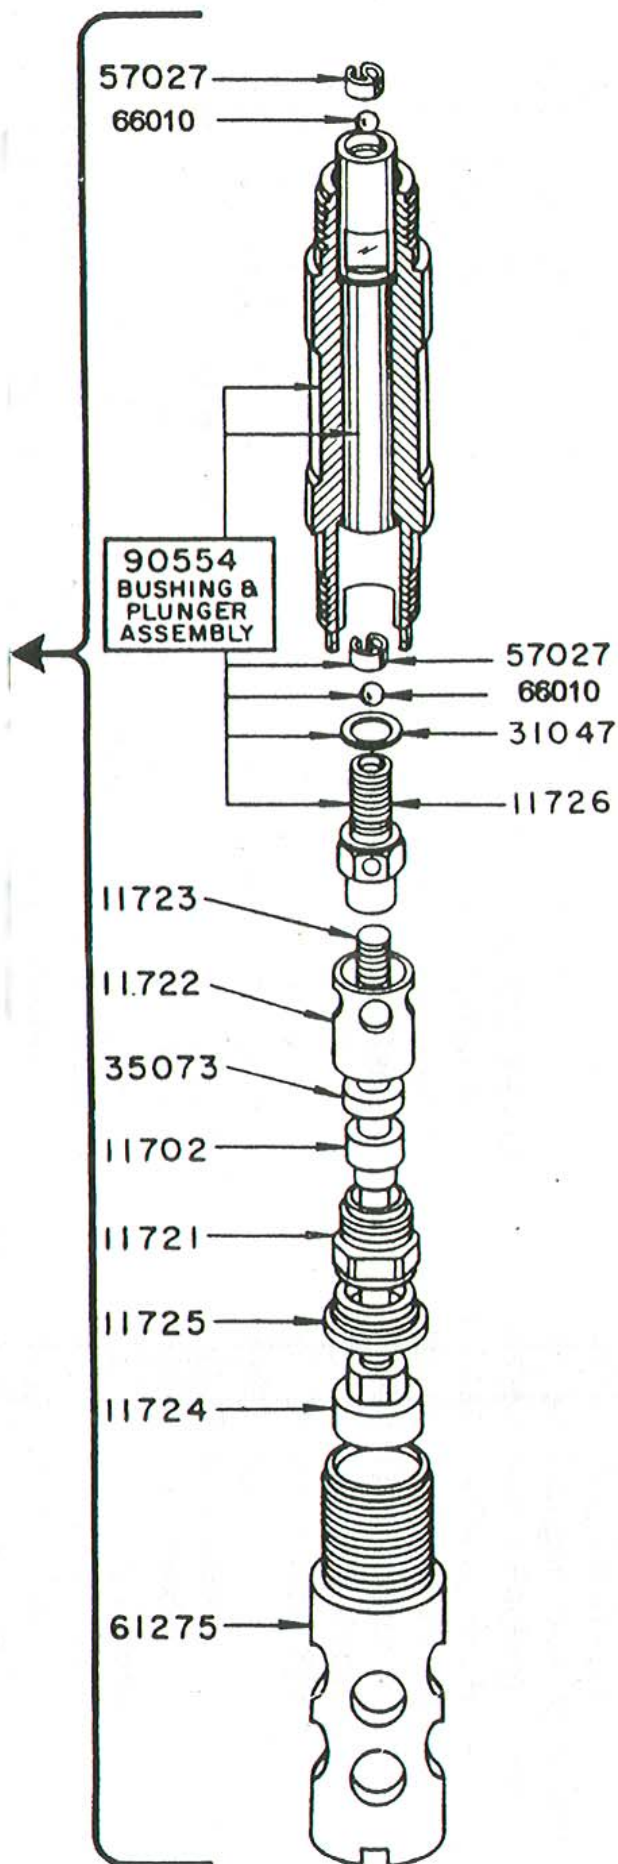
When reassembling the plunger assembly, **NOTE #1:** The top and bottom of the plunger assembly. You were careful in the beginning and noted it when you took it apart. **NOTE #2:** notice the order of the ball and cage. Starting from the bottom, it is ball ; cage; then at the top of the plunger it is cage; ball; If you reverse this order, the pump will not operate at all.

The gasket ring 31047 and 11726 is inserted onto the bottom of the plunger. Use the milled flats to tighten 11726. Assemble the balance of the items in reverse order to disassembly. Note the drawing to the left. When reinstalling the bushing extension 61273(not shown), install the unit over the other interior parts and let it hang loose. Thread the rod 11723 onto the bottom of 11726. To tighten the rod, you will have to insert a small punch into the hole of 11726. See Fig B on page 1. We are now tightening the rod 11723 by putting a wrench on the plunger 11724. Assemble balance of items as shown.
