**AIR OPERATED CHASSIS PUMP**

**50:1 RATIO, OUTPUT – 80 CU. IN./MIN.  
MIN. AIR PRESSURE – 30 PSI  
MAX. AIR PRESSURE – 150 PSI  
MAX. OUTPUT PRESSURE – 7500 PSI  
*RECOMMENDED OPERATING PRESSURE 80-100 PSI***

**OWNERS MANUAL**

## CHASSIS LUBRIGUN

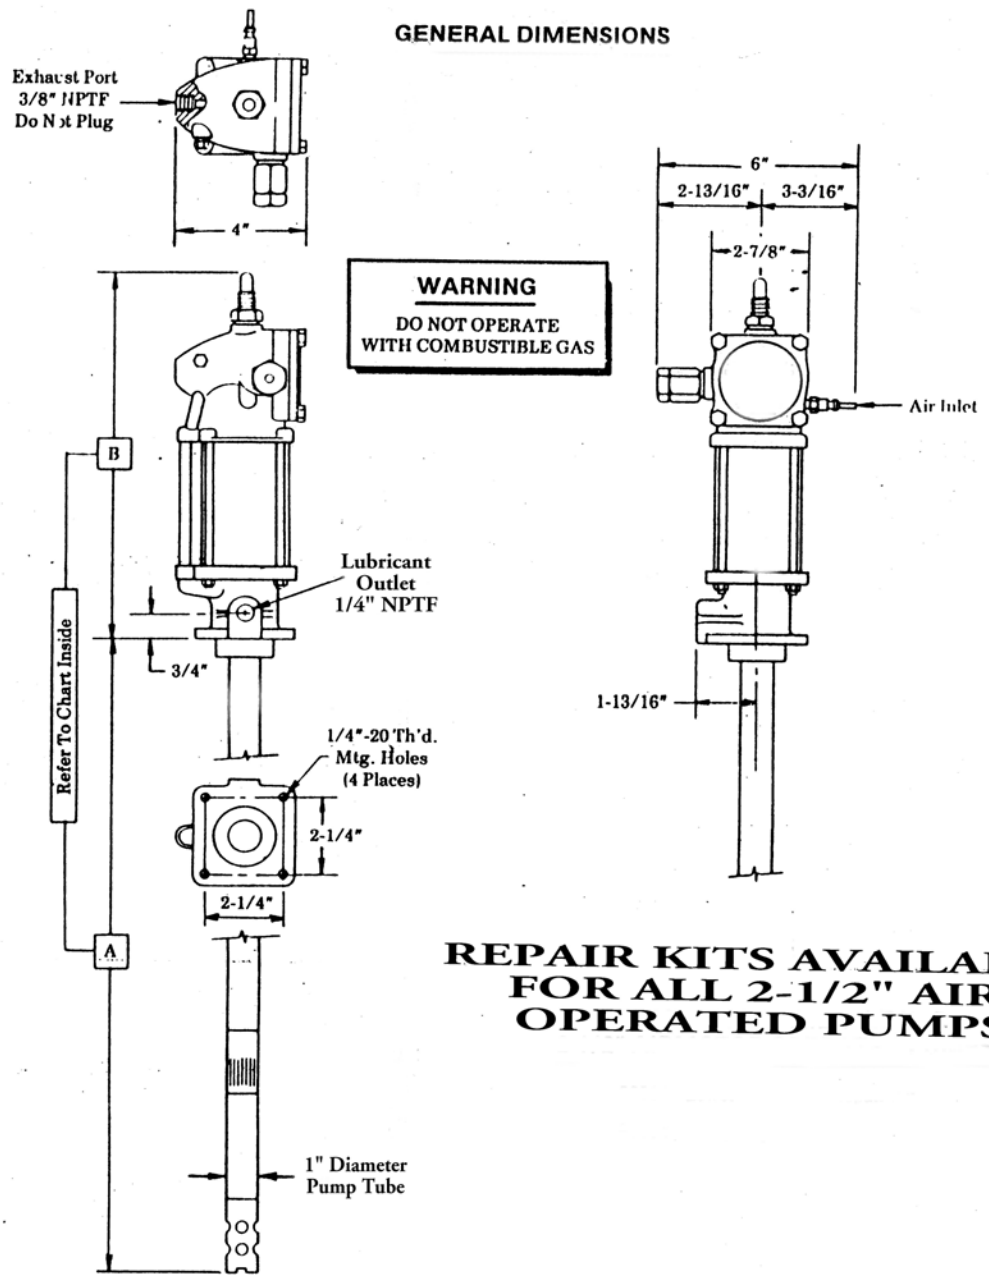
# MODEL ATD5219-1

Dim "A" = 33-15/16"; Dim "B" = 11"

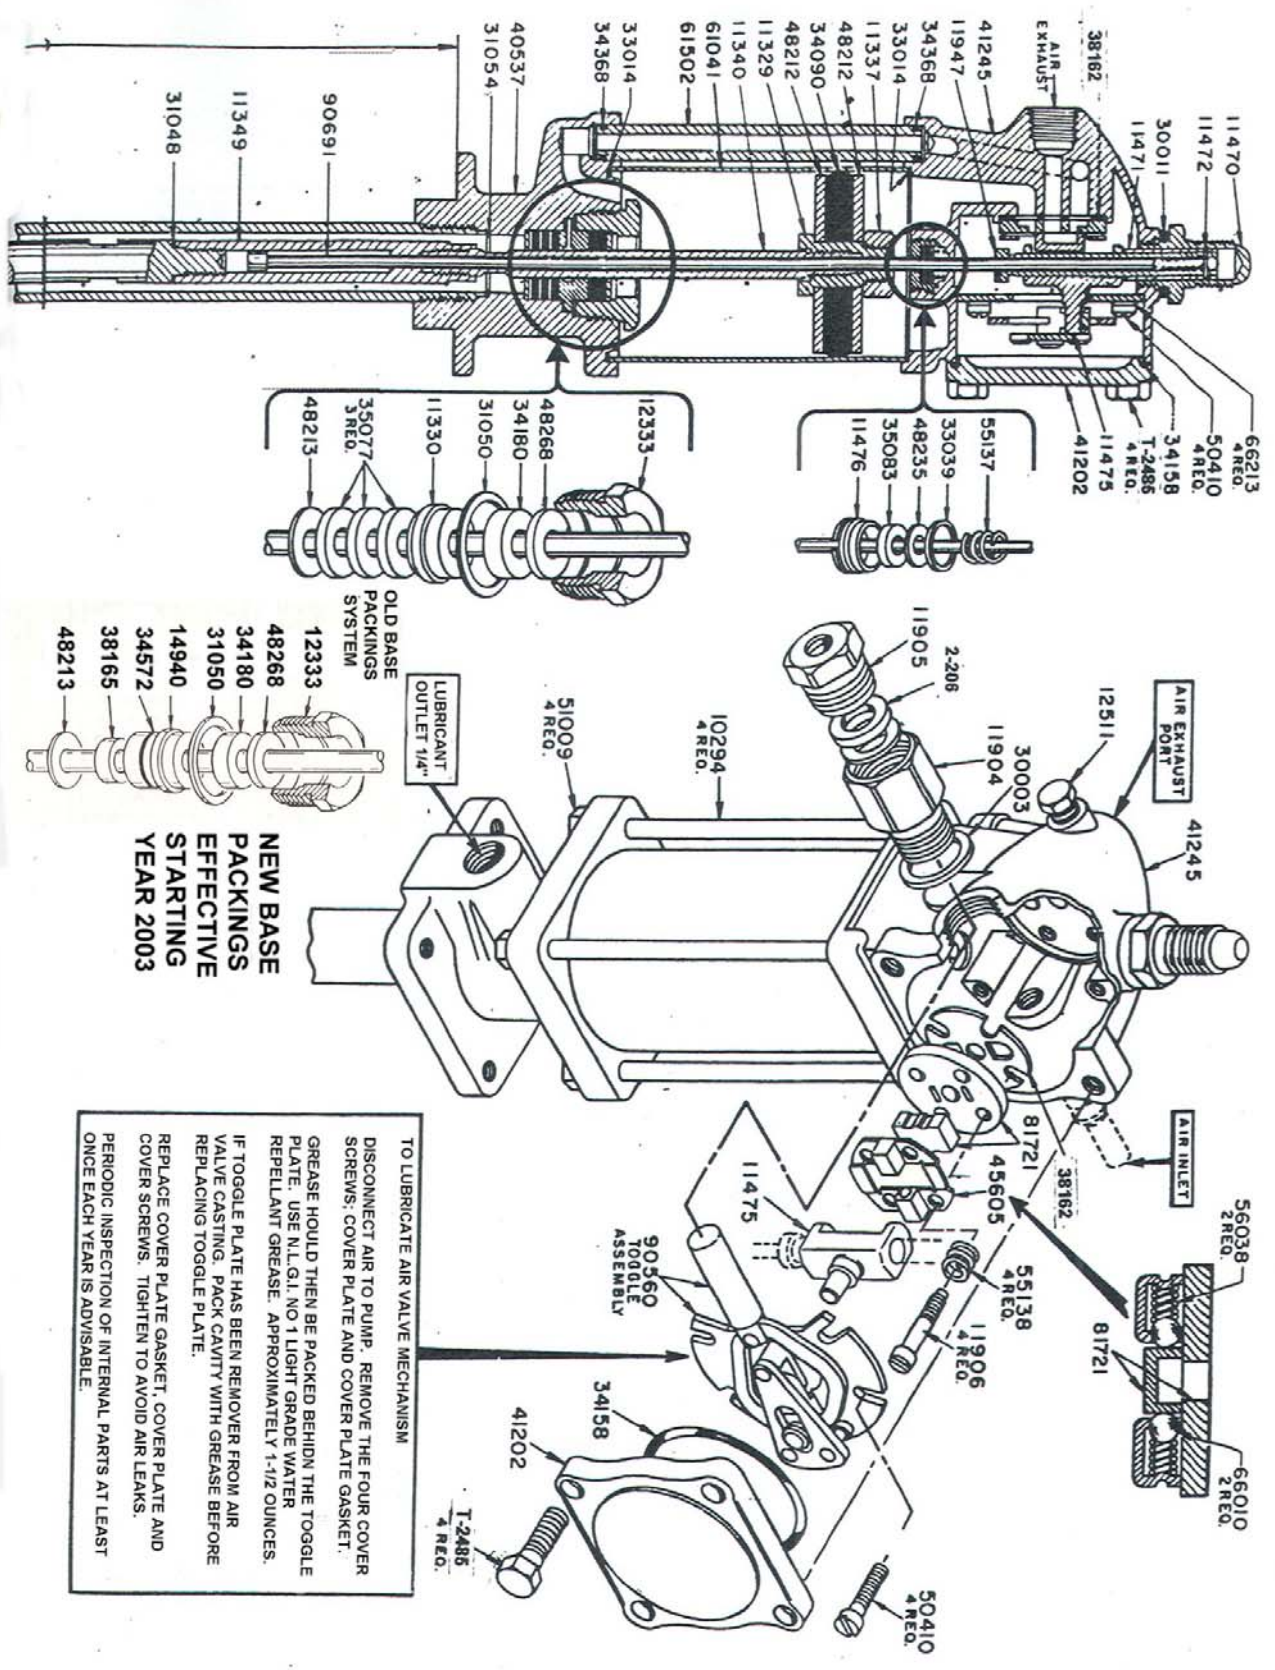
**TO LUBRICATE AIR VALVE MECHANISM**  
 DISCONNECT AIR TO PUMP. REMOVE THE FOUR COVER SCREWS: COVER PLATE AND COVER PLATE GASKET. GREASE SHOULD THEN BE PACKED BEHIND THE TOGGLE PLATE. USE N.L.G.I. NO 1 LIGHT GRADE WATER REPELLANT GREASE. APPROXIMATELY 1-1/2 OUNCES. IF TOGGLE PLATE HAS BEEN REMOVED FROM AIR VALVE CASTING. PACK CAVITY WITH GREASE BEFORE REPLACING TOGGLE PLATE. REPLACE COVER PLATE GASKET, COVER PLATE AND COVER SCREWS. TIGHTEN TO AVOID AIR LEAKS. PERIODIC INSPECTION OF INTERNAL PARTS AT LEAST ONCE EACH YEAR IS ADVISABLE.

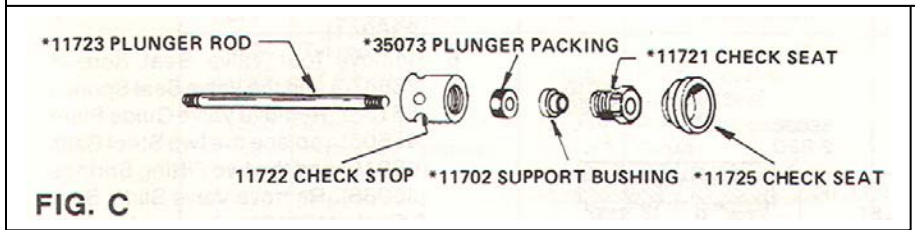
FIG. C

**FIG C:** (See Fig. C) When you remove the Extension Tube (61273) this exposes the Check Seat (11725), Priming Check (11721), Check Stop (11722), Support Bushing (11702) and Plunger Packing (35073).

**Note:** Unscrew Priming Check Seat (11721) from Check Stop (11722) to remove Support Bushing (11702) and Plunger Packing (35073); To do this you will have to put Check Seat (11721) in a vise and insert a point tool such as a punch through the holes in Check Stop (11722) to unthread Check Stop (11722) from Check Seat (11721).

Plunger Packing (35073) incurs heavy wear and it is advisable to replace this part if worn.
